S_____ Monitoring Report¹

Pre and post project photo point monitoring is utilized to document surface erosion and sediment transport for the S_____ Clean Up and Abatement Order and Fish and Game violations as noted in the Interim Sediment and Erosion Control Plan approved by CDFW and the Water Board.

Updated Photo Point Monitoring: December 16th, 2016

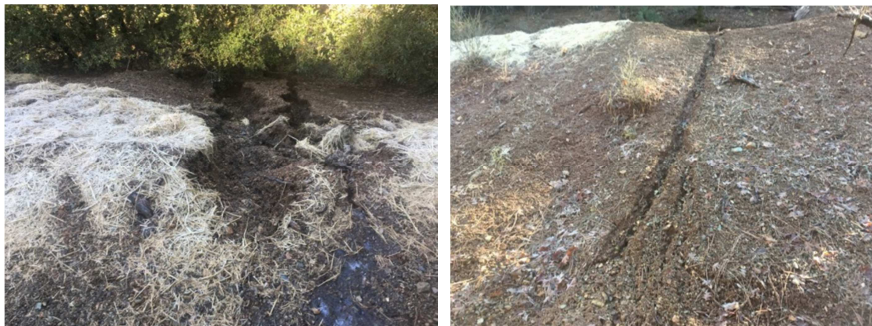
One new gully and rill were observed and mapped during the site visit. The gully is bank discharge off of Road "A" above Boyer Gulch (Figure 1 below) and was measured as an average of 6" deep x 8" wide x 60' long with a total erosion of 0.75 yd³. Approximately 50% of the eroded material is estimated to have delivered to the floodplain with less than that total actually being transported to the stream channel. The gully is located approximately 50' east of a much larger gully that appears to have been the previous road drainage discharge point. The road drainage installed under this project has substantially reduced the amount of runoff directed to this site. The rill observed was the result of runoff from Road E to Road A (photos below) and represents the effects of a new rolling dip installed on Road E. The total rill volume is <0.2 yd³ of material which has settled above Road A and will not reach waters of state.

Above Left- A small gully formed off of Road "A" and Above Right- A rill from Road "E" to Road "A"

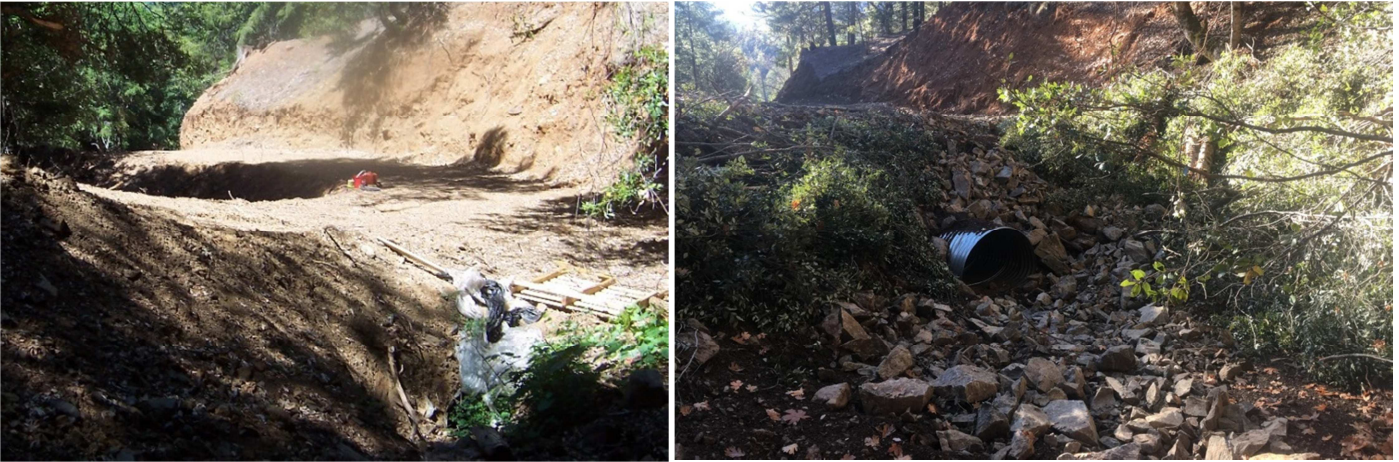
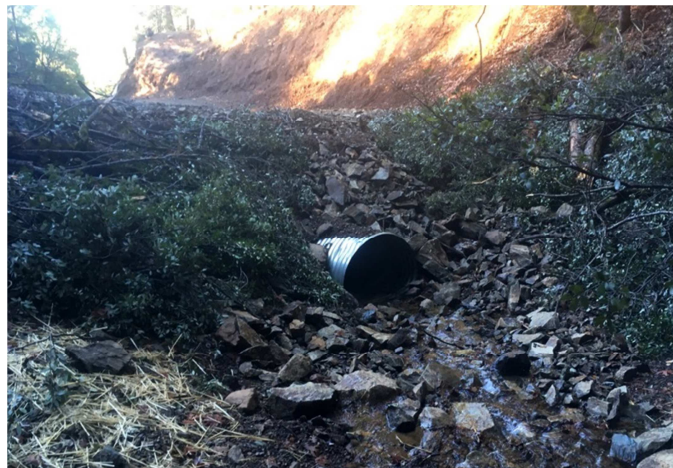
Crossing #2- Tributary to Long Canyon

Crossing #2 Inlet (Above) before project. The 18" x 40' CMP culvert was removed and replaced and realigned with a 29" x 43" squash CMP culvert and the channel inlet and outlet rock armoured. Above Right (November 18, 2016)- The outlet was aligned with the channel. Vegetation was packed at the inlet and outlet and certified weed free straw mulch and native seed mix placed on-site. All liter was collected and disposed of at the Trinity County Solid Waste facilities. Below- Same as above with active channel flow (December 16, 2016).

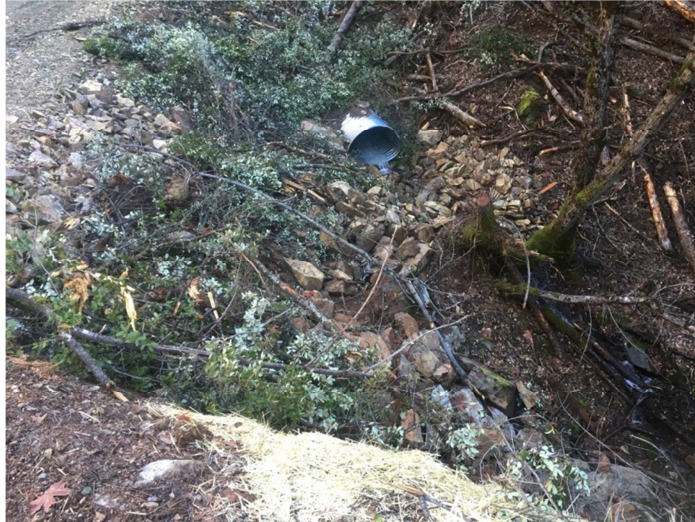
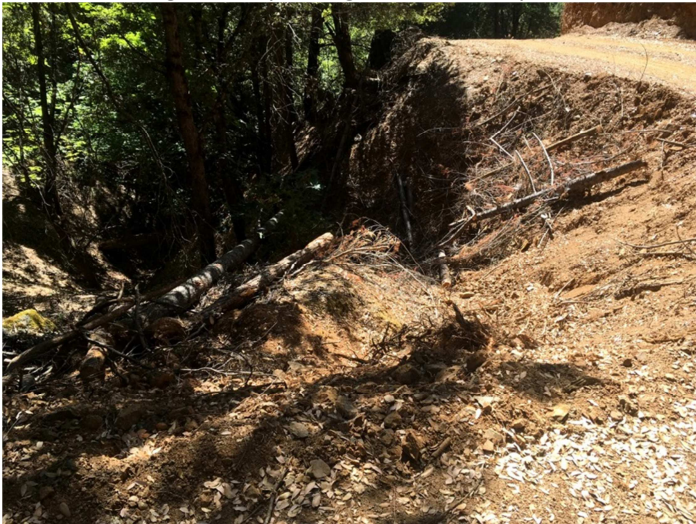
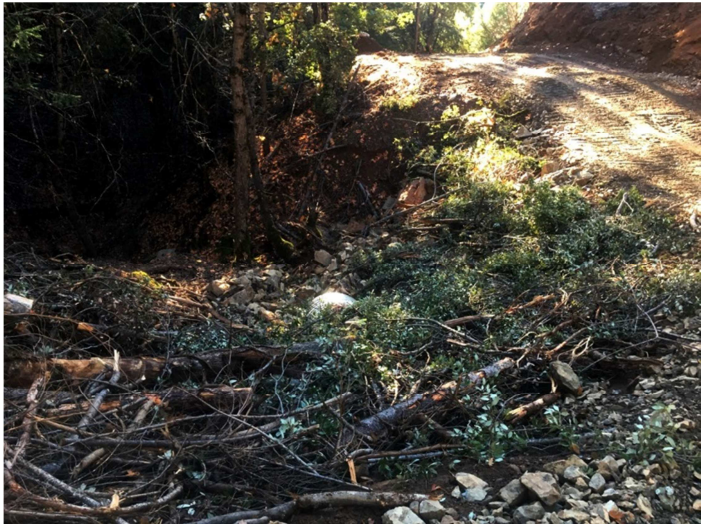
Above, outlet of Crossing #2 with active stream flow (December 16, 2016). Below Left Outlet pre-project. Below right, outlet with vegetation packing and critical dip (November 18, 2016).

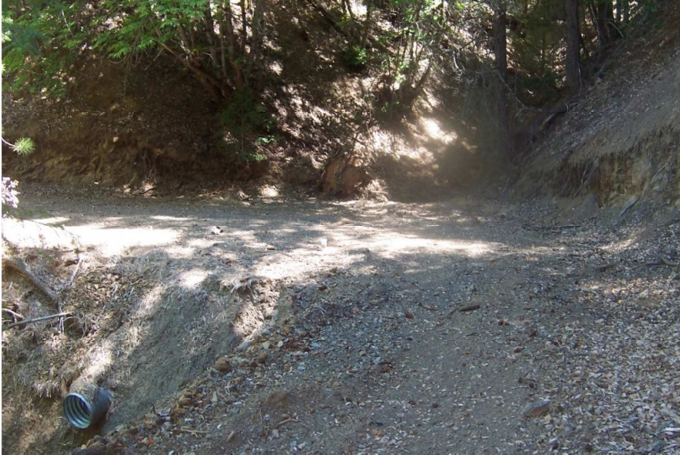
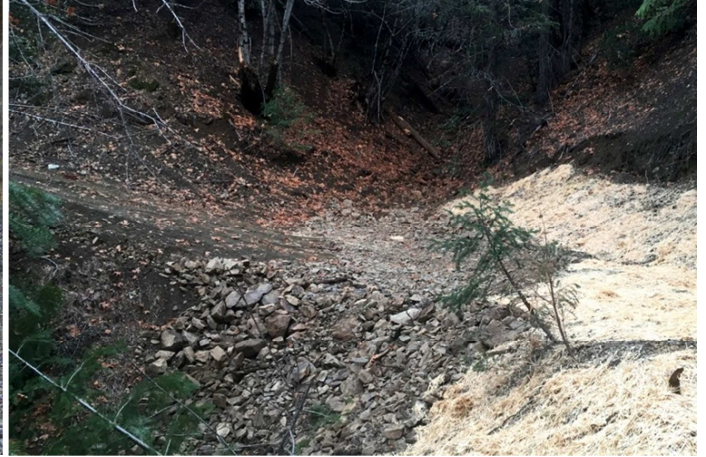
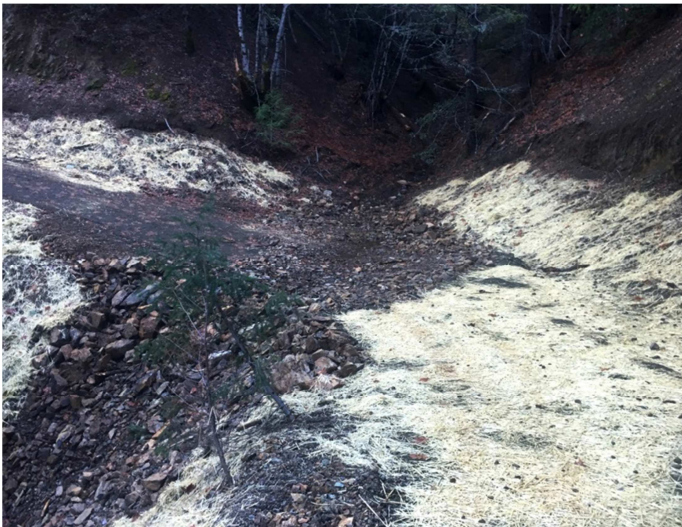
Crossing #3- Downstream- Same Tributary as Crossing #2

Above Left- Before showing 18" CMP culvert perched in fill. Above Right- Culvert excavated out and armored rolling dip installed with critical dip and large rock installed into road and on outlet end (November 18th, 2016). Below same site following return of surface flows (December 16, 2016).

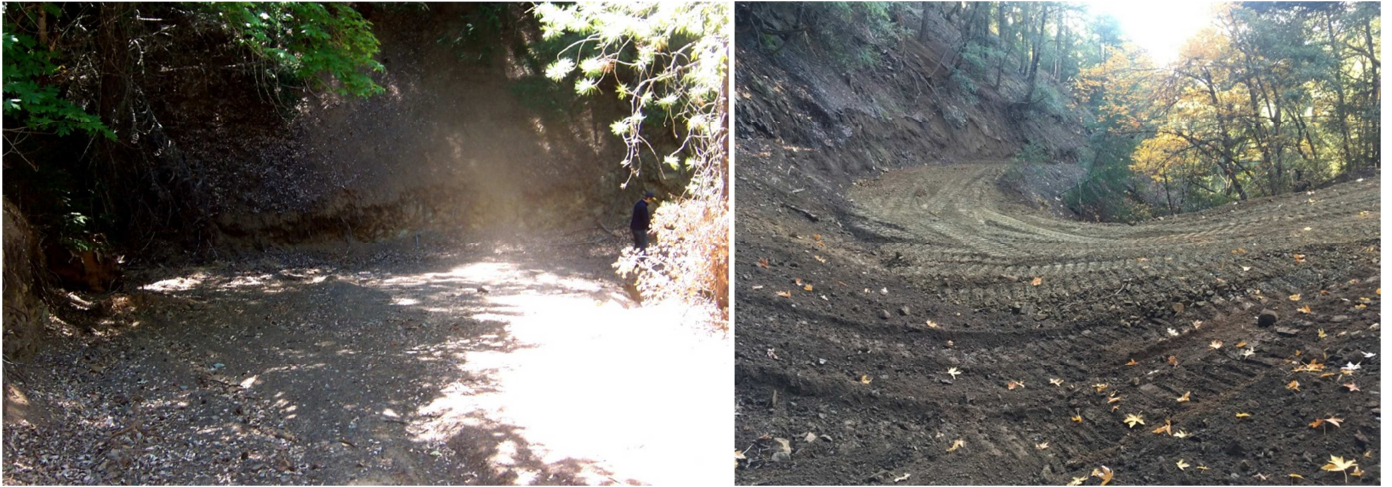
Below Left- Crossing #3 before project. Below Right- Digging out the crossing before installing large rock in crossing and outlet (November 11, 2016).

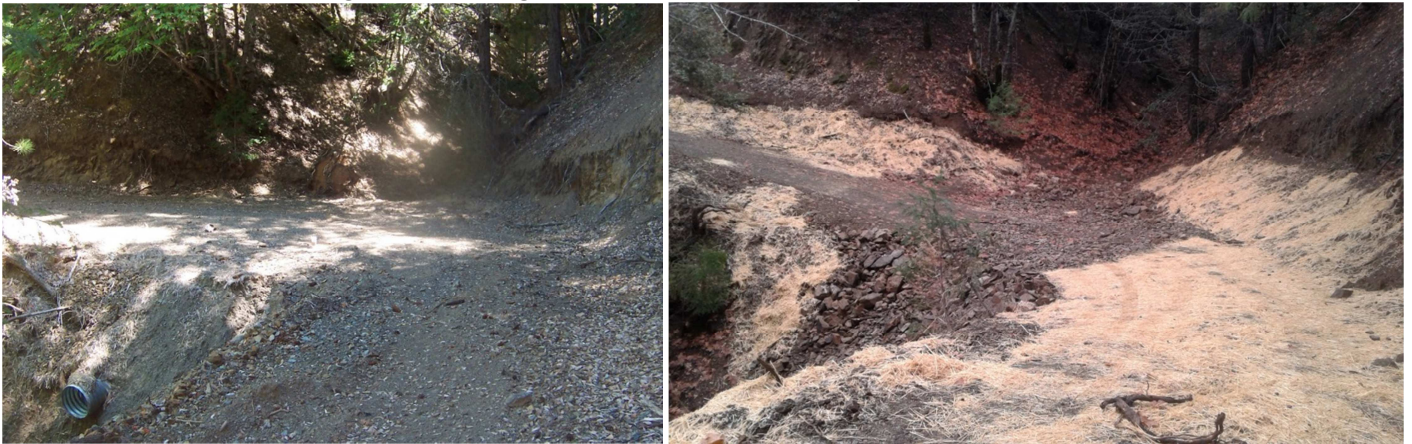
Below Left- Before at crossing site, Below Right- After rocked ford and dip are installed (November 22, 2016).

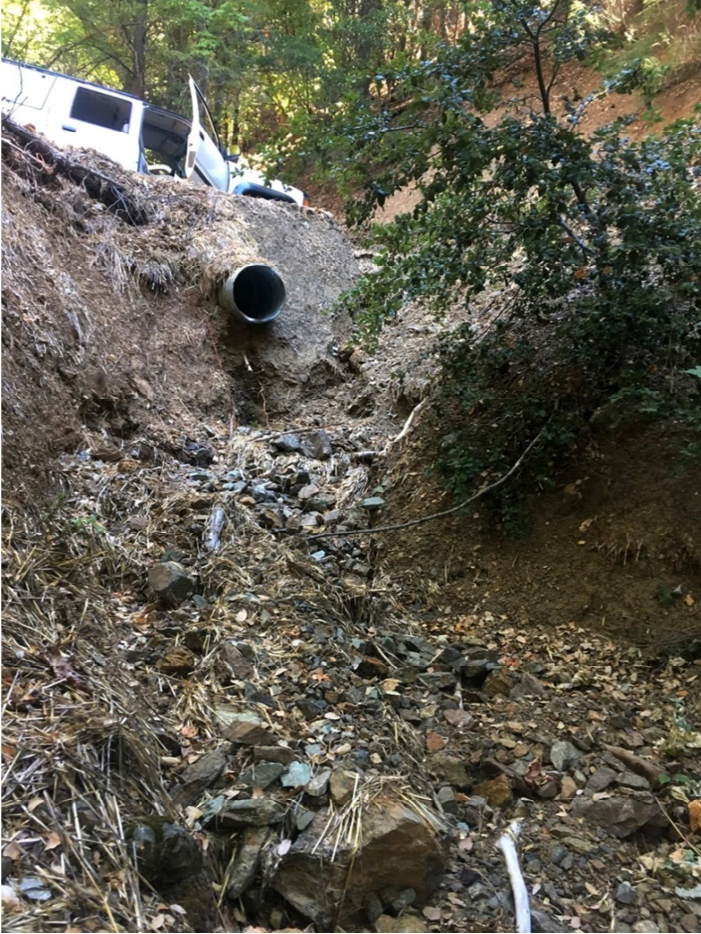
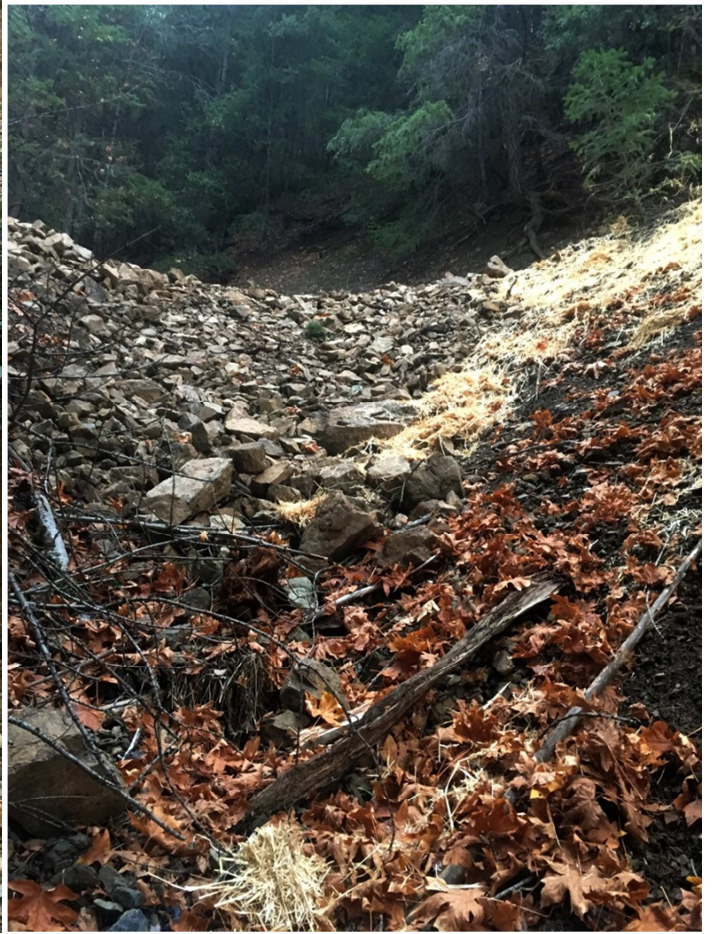
Crossing #3 before with perched culvert (Left) and after (Right) on November 18, 2016

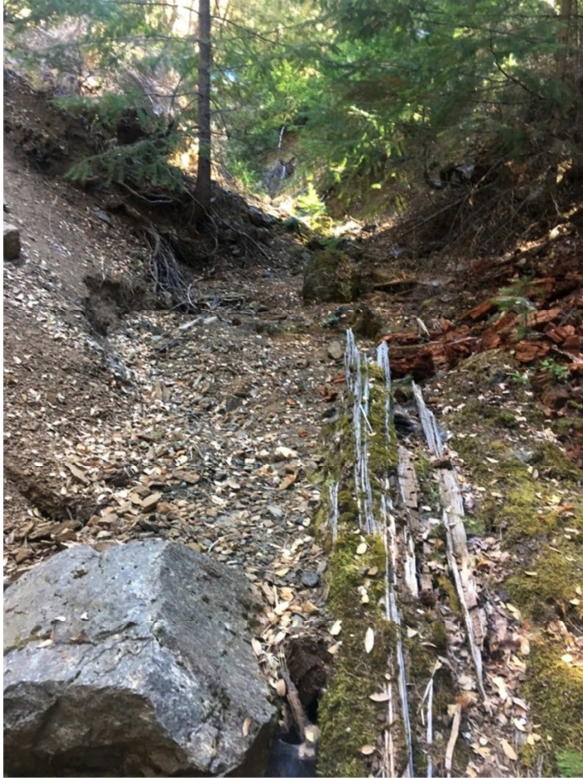
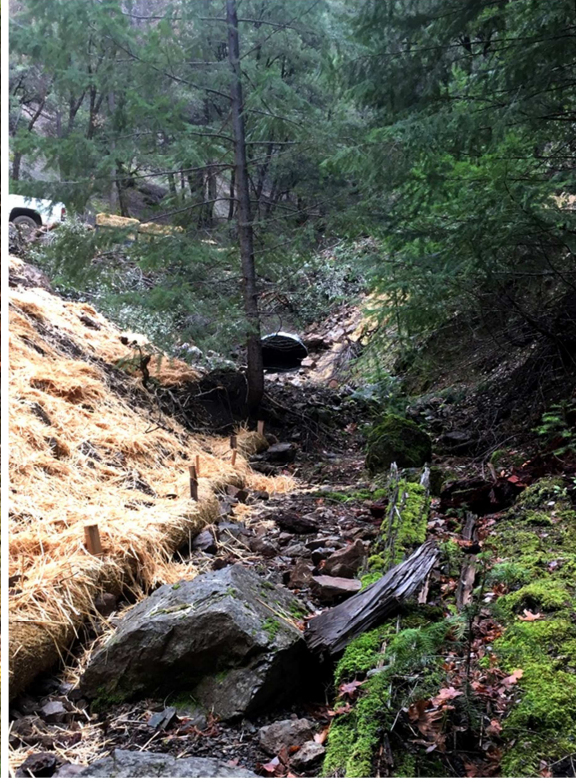
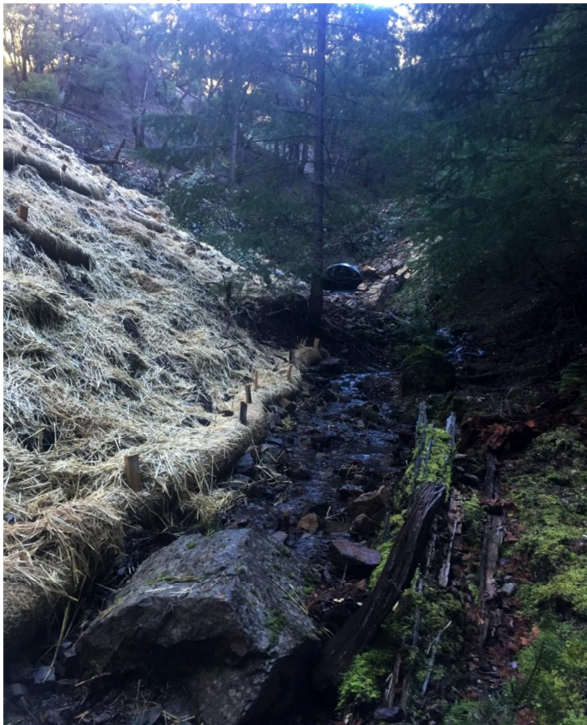
Crossing #1 Tributary to Boyer Gulch

Above Left- Downstream looking upstream to crossing before work. Above Right- Downstream looking upstream after work on both crossing and banks (11/18/2016). Below- After storm flows activated the stream channel (12/16/2016) with active channel flow present. No evidence of new sediment was observed in the channel.
