Updated Photo Point Monitoring: December 16<sup>th</sup>, 2016

### Crossing #4 & 6- Tributary to Long Canyon

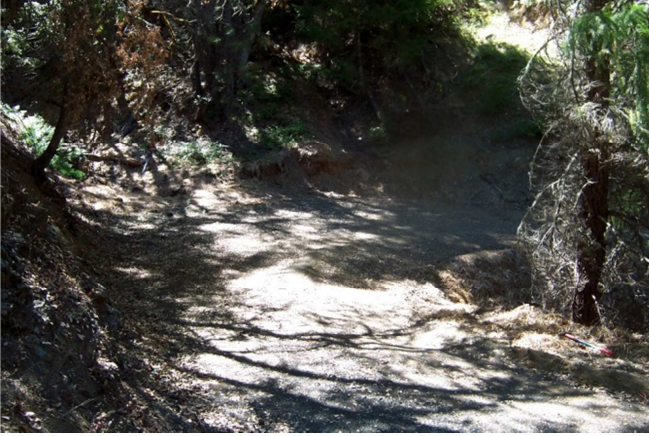
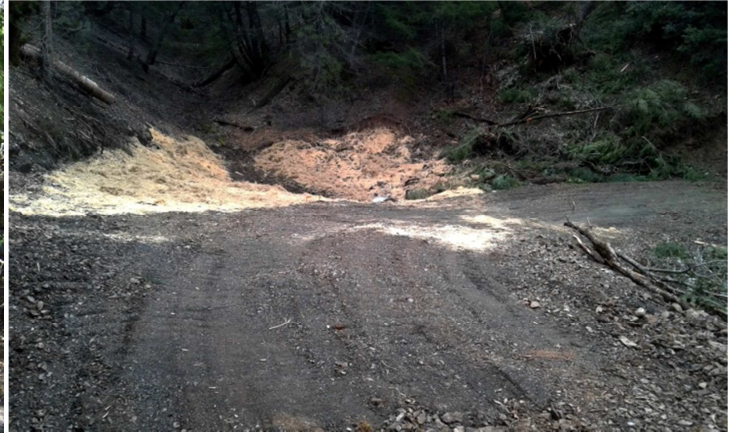
Below Left- Before with 18" CMP culvert misaligned and ~60' of fill material in crossing. Below Right- After showing realigned 49"x 33" CMP culvert and ~20' of removed fill in crossing.

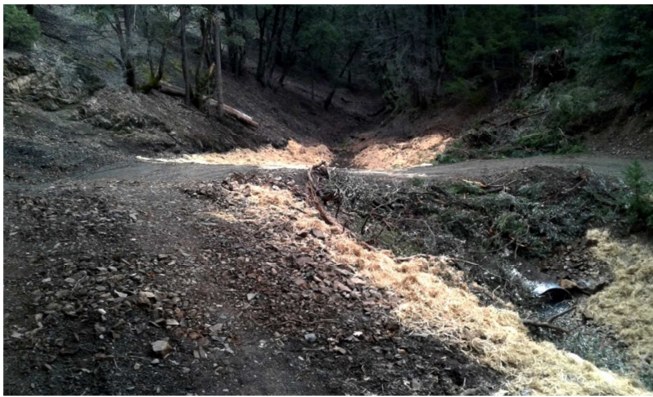
Above- Realigned and enlarged CMP crossing with vegetation packing, seed and mulch with rock armoring. Critical dip and rocked dip can be seen on either side of crossing (November 22, 2016).

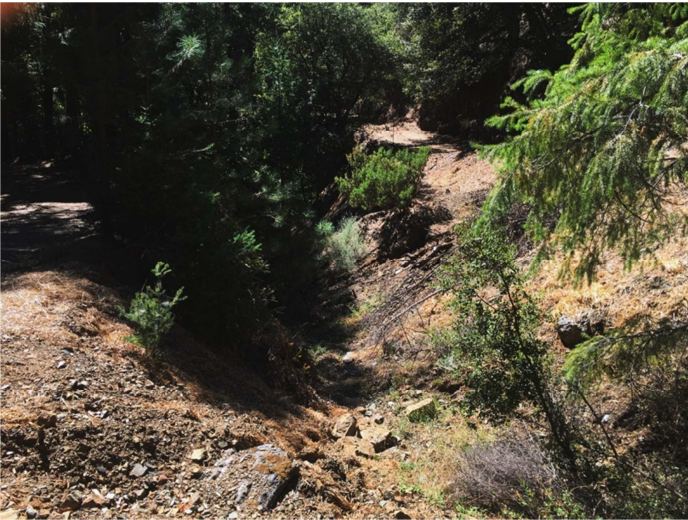
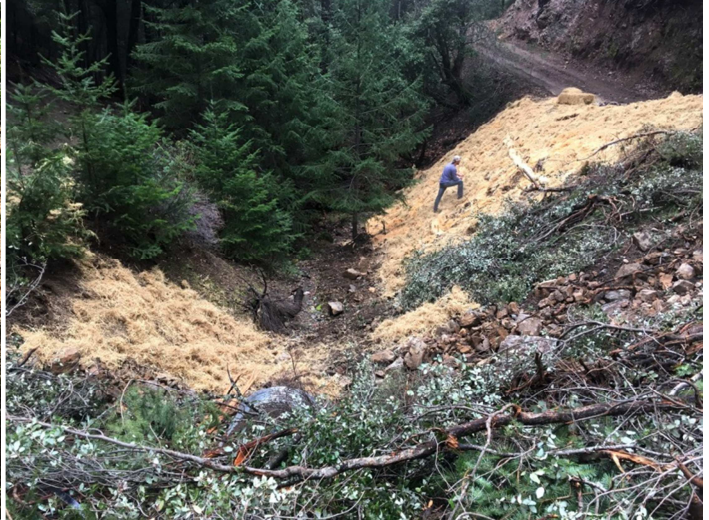
Above Left- Pre-project crossing. Above right- Post project crossing downstream view from crossing showing stabilized banks, vegetation packing (November 22, 2016). Below- Same area with active channel flow and effects of approximately 8" of rain on site (December 16, 2016).

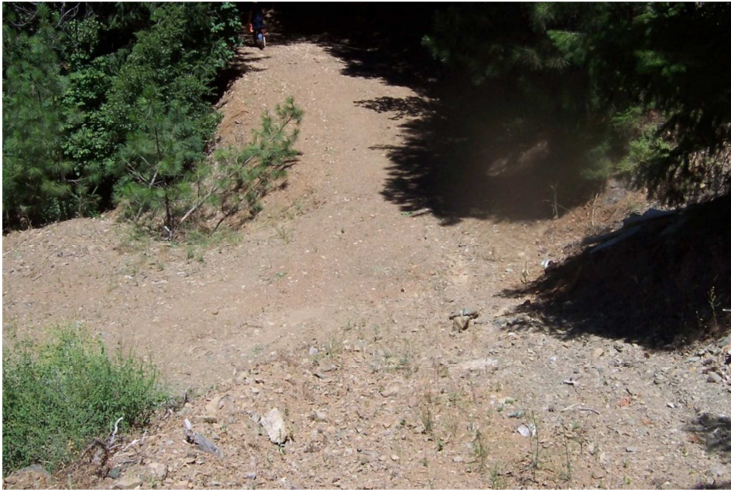
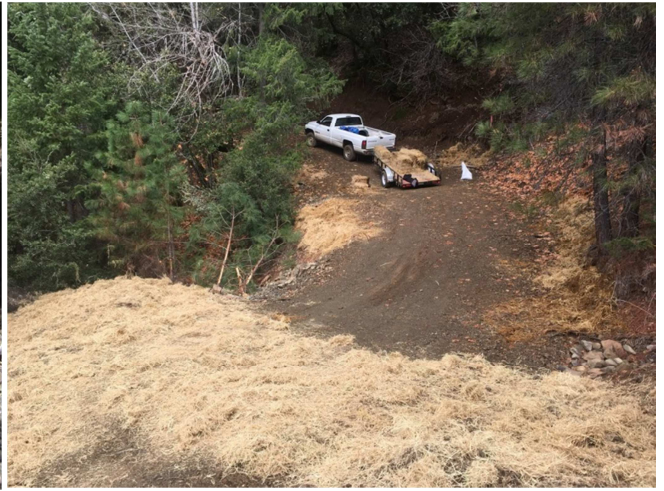
Above Left Crossing #4 (Center of Photo) and Crossing #6 (arrow) before. Above Right- Rocked fords were installed at both crossing (the trailer is in the center of the dip at Crossing #6 (November 22, 2016).

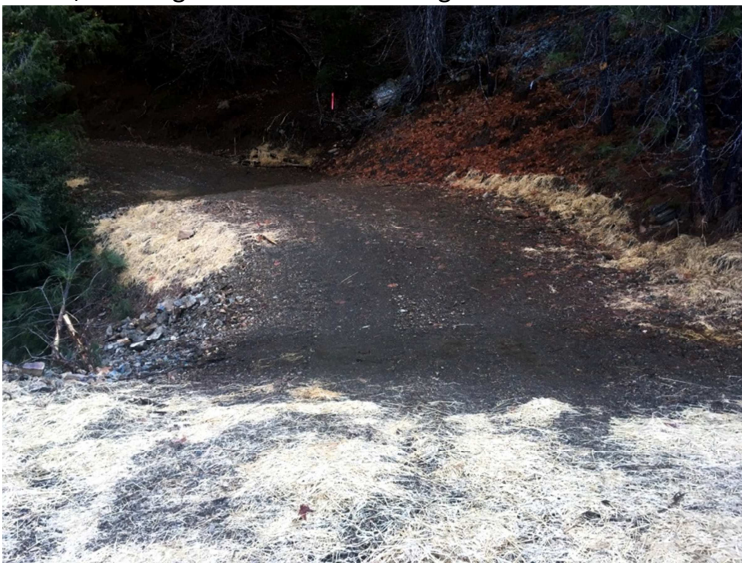
Below, Crossings 4 and 6 with Crossing 6 with active flow and crossing 4 dry (December 16, 2016).

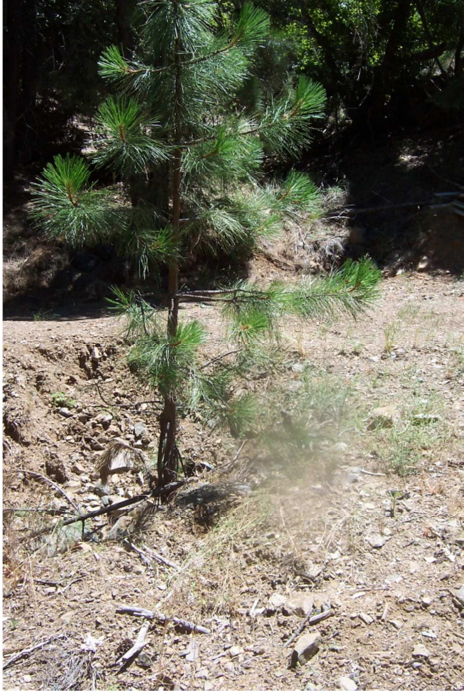
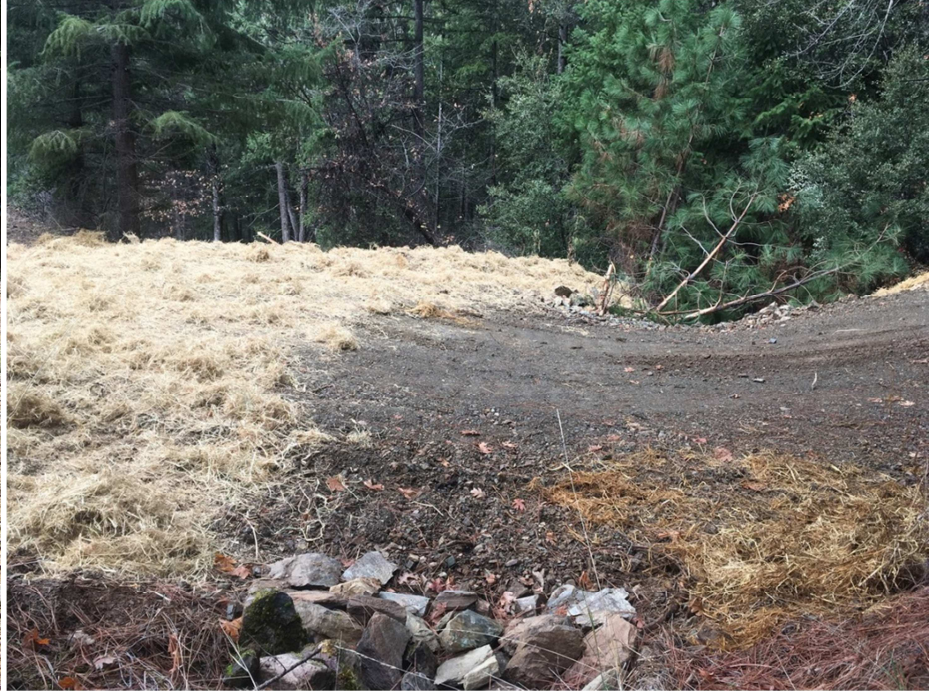
Crossing #4 outlets (before) on the left and the rolling dip inlet on the right.

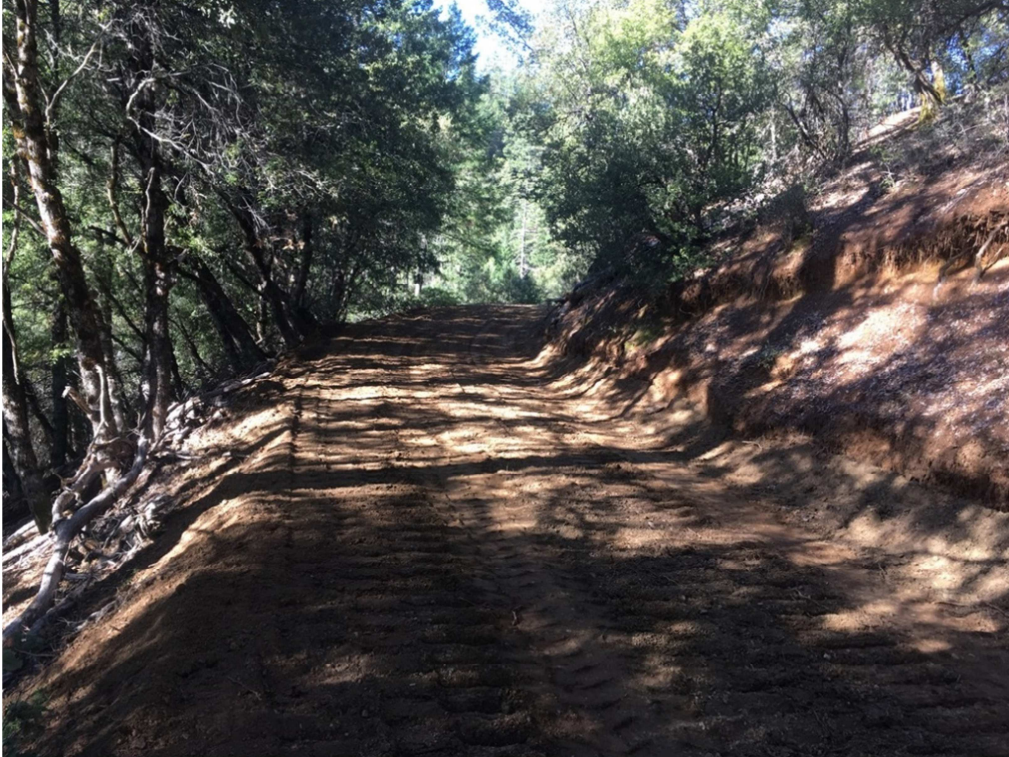
Typical road segment with berm removed and road outsloped to 4-5%

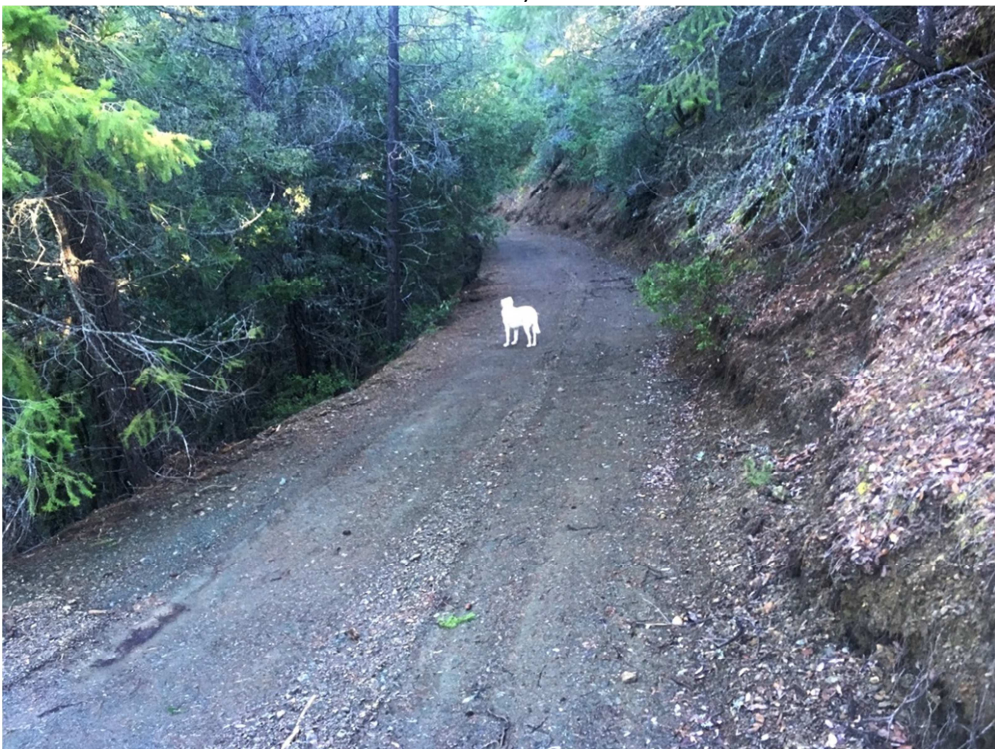
Above outsloped and berm removal (November 18, 2016) and another segment after significant rainfall (December 16, 2016).

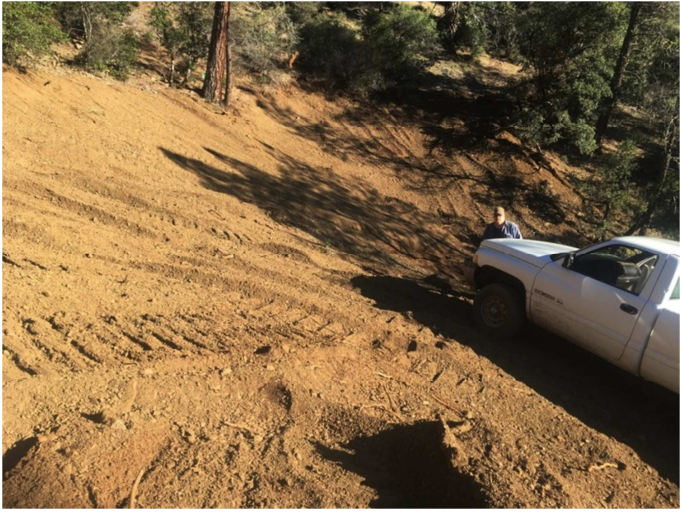
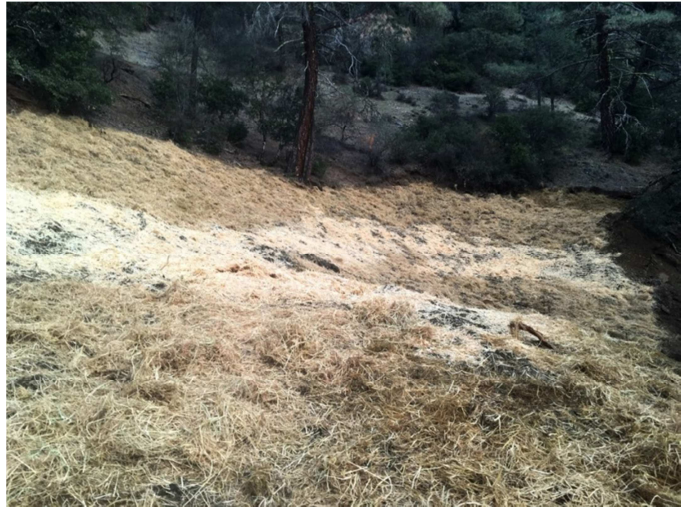
Above Left - Dig out of swale (Site #6) (November 14, 2016) and seed and mulching of the site (Above Right- November 18, 2016). Below Left- Same site on December 16, 2016)
